APPENDIX A - GEOTECHNICAL INVESTIGATION

**Rifle Falls SFU - Isolation Building
SCA23A**

October 26, 2023
Project#01963-0010

Subject: Geotechnical Investigation
Rifle Falls Iso Building
Rifle, Colorado

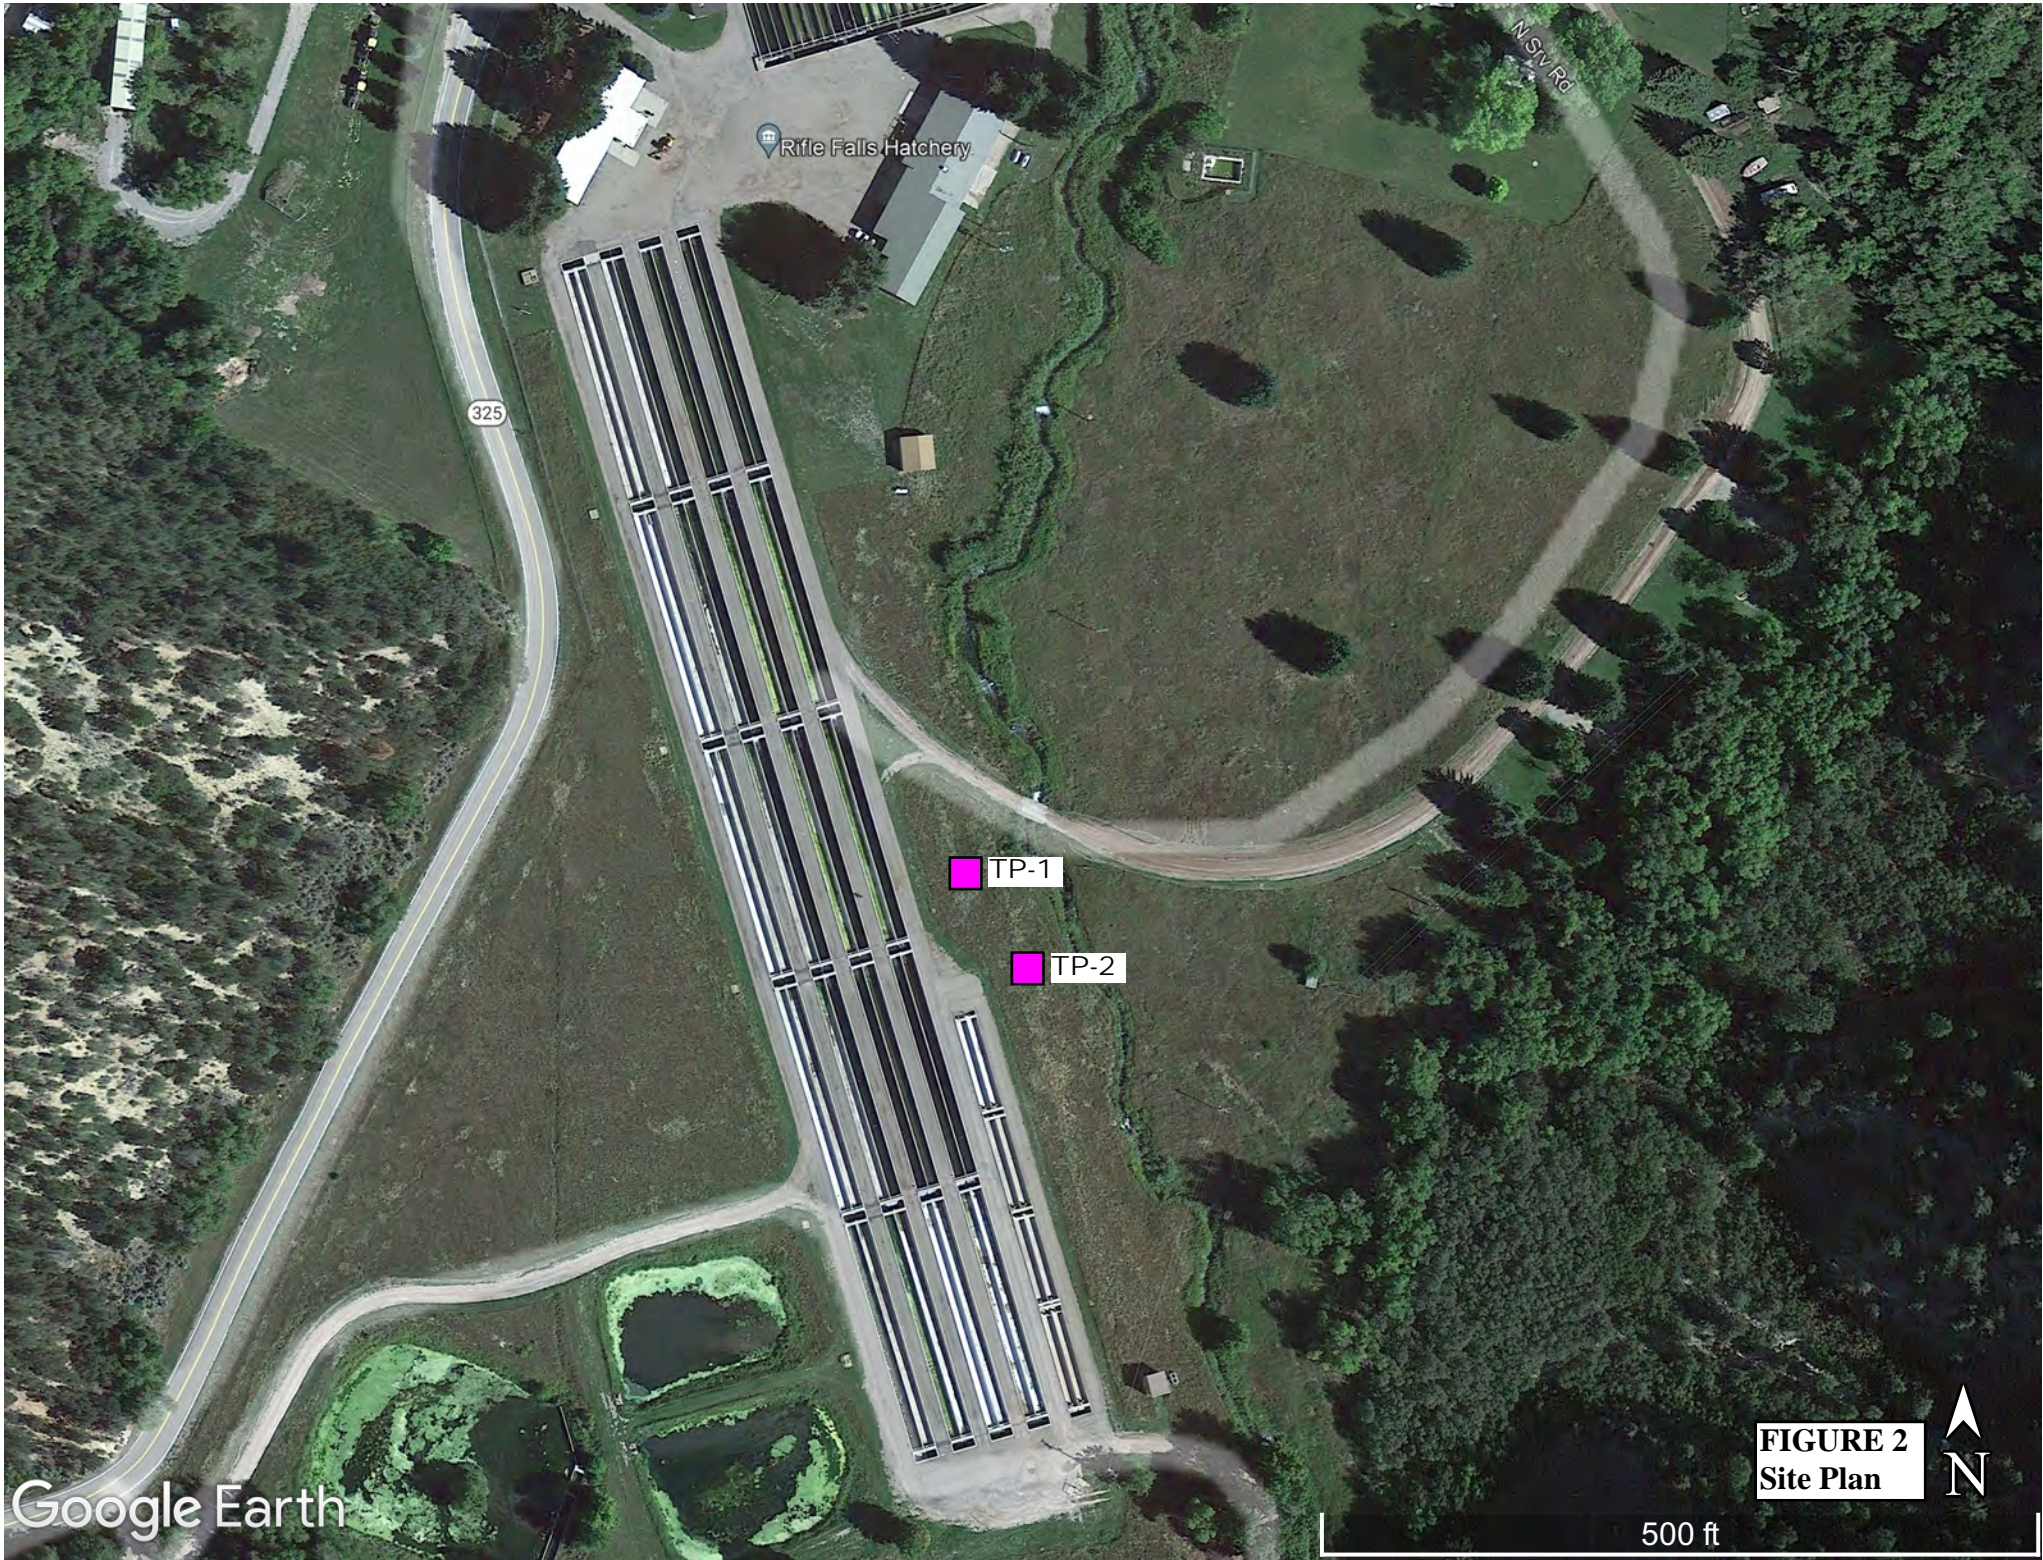
FIGURE 2
Site Plan

The subsurface investigation included two test pits as shown on Figure 2 – Site Plan. The test pits were excavated to depths of 8.0 and 9.0 feet below the existing ground surface. Typed test pit logs are included in Appendix A.

As indicated on the logs, the subsurface conditions encountered in the test pits were fairly consistent. The test pits encountered 0.5 to 1.0 foot of topsoil above brown, moist, medium dense to loose silt with sand soils that extended to the bottom of TP-1 and to a depth of 7.0 feet in TP-2. The silt soils in TP-2 were underlain by brown, moist, loose silty sand soils to the bottom of the excavation. Groundwater was not encountered in the subsurface at the time of the investigation.
